# Manhole Inspection Summary

Manhole # S21U\_\_001MH

Insp Date: **5/7/09 7:43 AM**

**Location** Address: **1903 WASHINGTON BLVD** Cross Street: **CARROLL PARK**

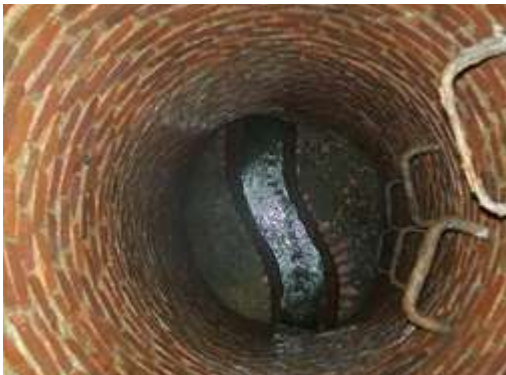
Defect 1

corroded steps; bench debris

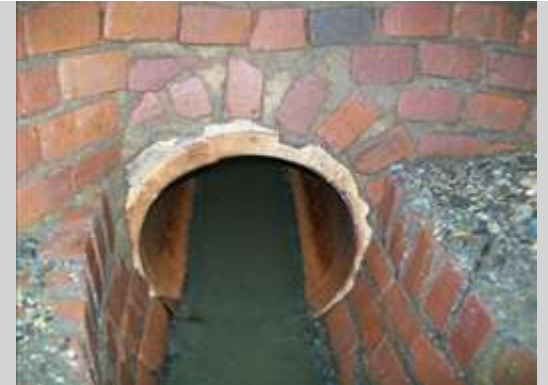
12 O'Clock Outflow

15 in. Circular Gravity Sewer  
Pipe Out @ 12 O'Clock

Pipe Height: **15.6** (in.) Rod and Bar (Angled)  
Pipe Material: **Clay** ☐ Pipe Lined  
Invert Depth: **13.80** (ft.) Flow Characteristics: **Slow**  
Deposits: ☒ None ☐ Mud ☐ Sludge ☐ Debris ☐ Grease  
Silt Depth: **0** (in.) Deposits Extent:  
Infiltration: **None** Pipe Seal Cond: **Sound**

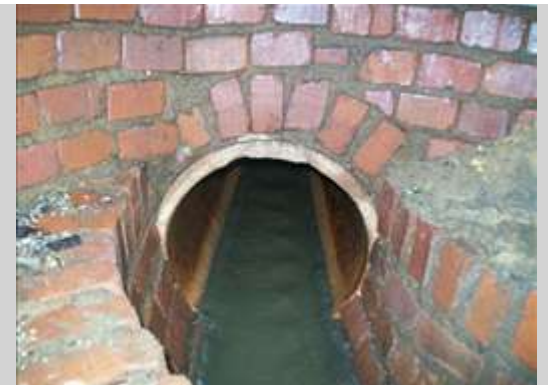
6 O'Clock Inflow

15 in. Circular Gravity Sewer  
Pipe In @ 6 O'Clock

Pipe Height: **15.6** (in.) Rod and Bar (Angled)  
Pipe Material: **Clay** ☐ Pipe Lined  
Invert Depth: **13.75** (ft.) Flow Characteristics: **Slow**  
Deposits: ☒ None ☐ Mud ☐ Sludge ☐ Debris ☐ Grease  
Silt Depth: **0** (in.) Deposits Extent:  
Infiltration: **None** Pipe Seal Cond: **Sound**
